CIVIL AND ENVIRONMENTAL ENGINEERING DEVELOPMENT OFFIC--ETC F/G 4/1
PHOTOGRAPHIC MEASUREMENTS OF USAF AIRCRAFT PLUME RISE.(U)
NOV 77 P D MUSIC, J S HUNT, D F NAUGLE
CEEDO-TR-77-57

CEEDO-TR-77-57

PHOTOGRAPHIC MEASUREMENTS OF USAF AIRCRAFT PLUME RISE

CIVIL AND ENVIRONMENTAL ENGINEERING DEVELOPMENT OFFICE

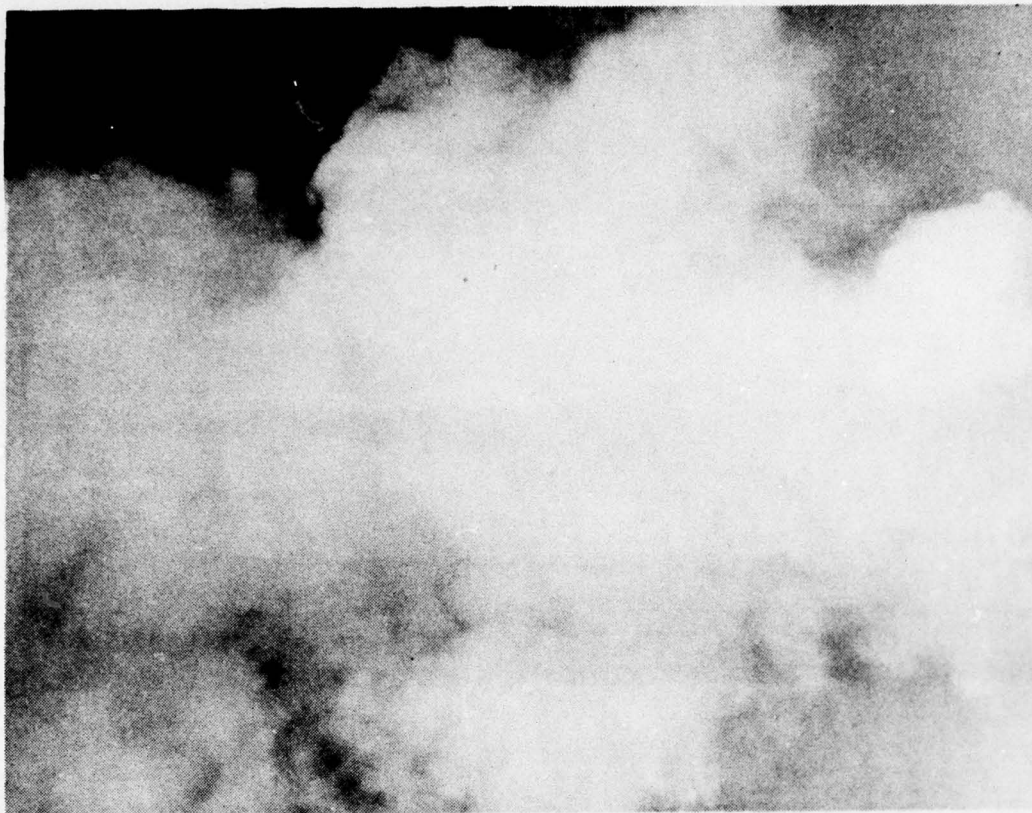
Figure 3. Photographs of T-38 Aircraft Plume Forming Mushroom Cloud: Test 1

Test 1. The first test conducted at Nellis AFB provided the most surprising plume rise (Figure 1). There was no wind during the test, and the atmosphere was unstable. Ground separation began approximately two aircraft lengths behind the aircraft, and the plume continued to rise from the same point (Figure 2). The plume rose to approximately 50 to 60 meters and began to form a mushroom cloud which continued to grow (Figure 3). This was the most extreme plume rise condition encountered; however, the stationary aircraft continually feeding the plume may produce this apparent "chimney effect" where the plume rise is enhanced.

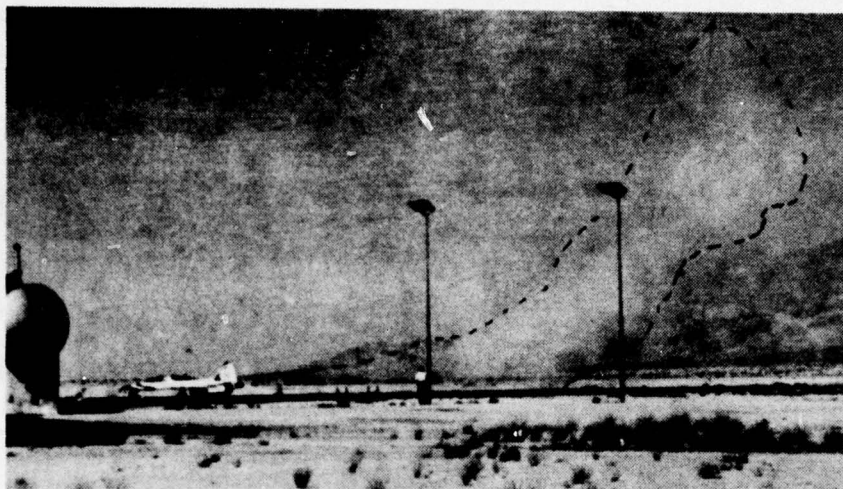
Test 4. The fourth test at Nellis AFB was made during slight winds and very unstable atmospheric conditions. In this case the greatest looping occurred. Looping began at approximately 50 meters off the ground (Figure 9 top photo), and then the entire loop continued to rise (Figure 9 bottom photo), forming a large arch. Ground separation began at approximately 45 meters behind the aircraft (Figure 10).

Figure 9. Photographs of T-38 Aircraft Plume: Test 4
